# PROCEEDINGS OF THE MERCHANT MARINE COUNCIL

July 1944

## Investigation of Failures in Welded Merchant Ships

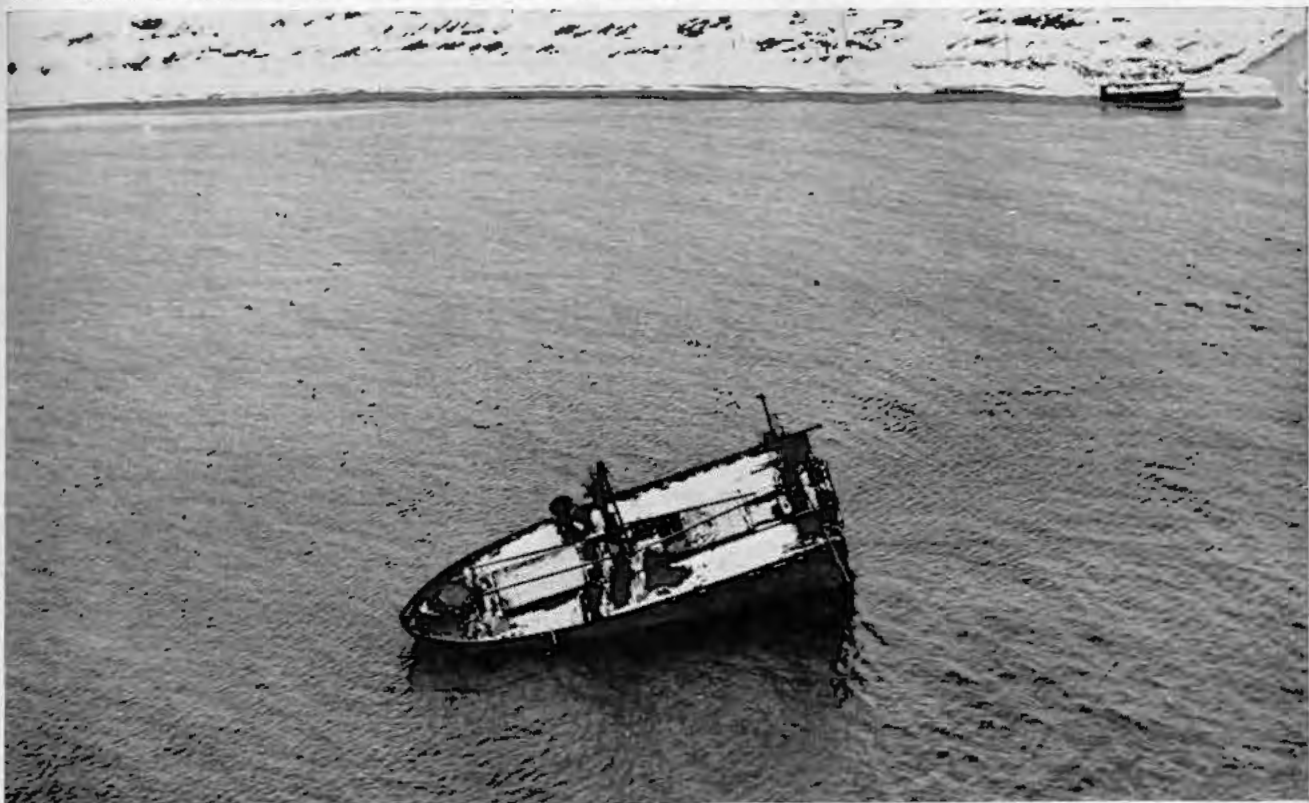
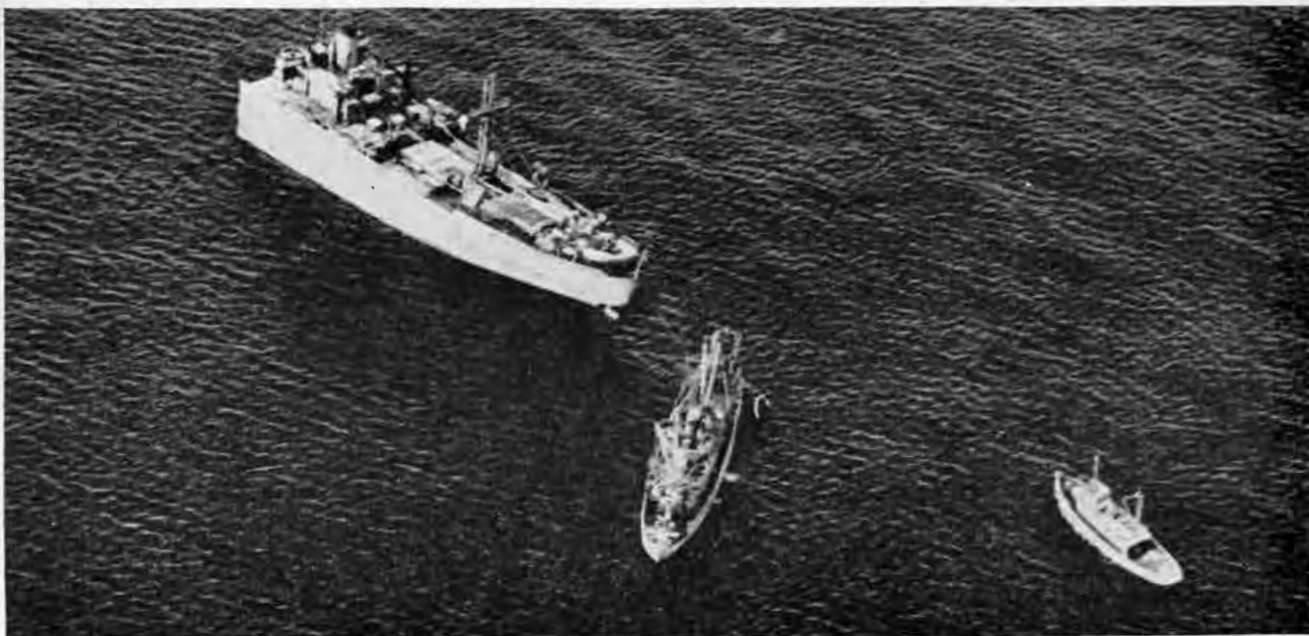
S.S. Valery Chkalov

APPARENT STARTING POINT <b>The cracks which finally broke the vessel started exactly in the forward corners of #3 hatch port and starboard.</b>
GENERAL HISTORY AND DESCRIPTION OF FAILURE, INCLUDING KNOWN CONTRIBUTORY FACTORS: <b>The vessel departed from Sovetskaya on 1 Dec., 1943, in ballast. Gales and heavy seas were encountered after departure. At noon on 11 Dec., 43, a loud report was heard and three cracks were found, one on the port side at Fr. #74; one on stbd. side at Fr. #74; and one on the stbd. side at Fr. #76. The port side crack extended from the hatch corner across the deck and down the shell to the bilge. The stbd. crack at Fr. #74 was in the side shell to the bilge. The stbd. crack at Fr. #74 was in the side shell from the sheer strake to the tween deck. The stbd. crack at Fr. #76 ran down the side shell from the sheer strake halfway down the tween decks. The vessel was taken in tow by the tug "Joseph Stalin" but at 2206 on 13 Dec. she broke completely in two. Both portions were taken in tow by U. S. Navy tugs and brought to anchorage. The crews did not abandon ship. Ballasting details will be made available by the USSR in the near future.</b>

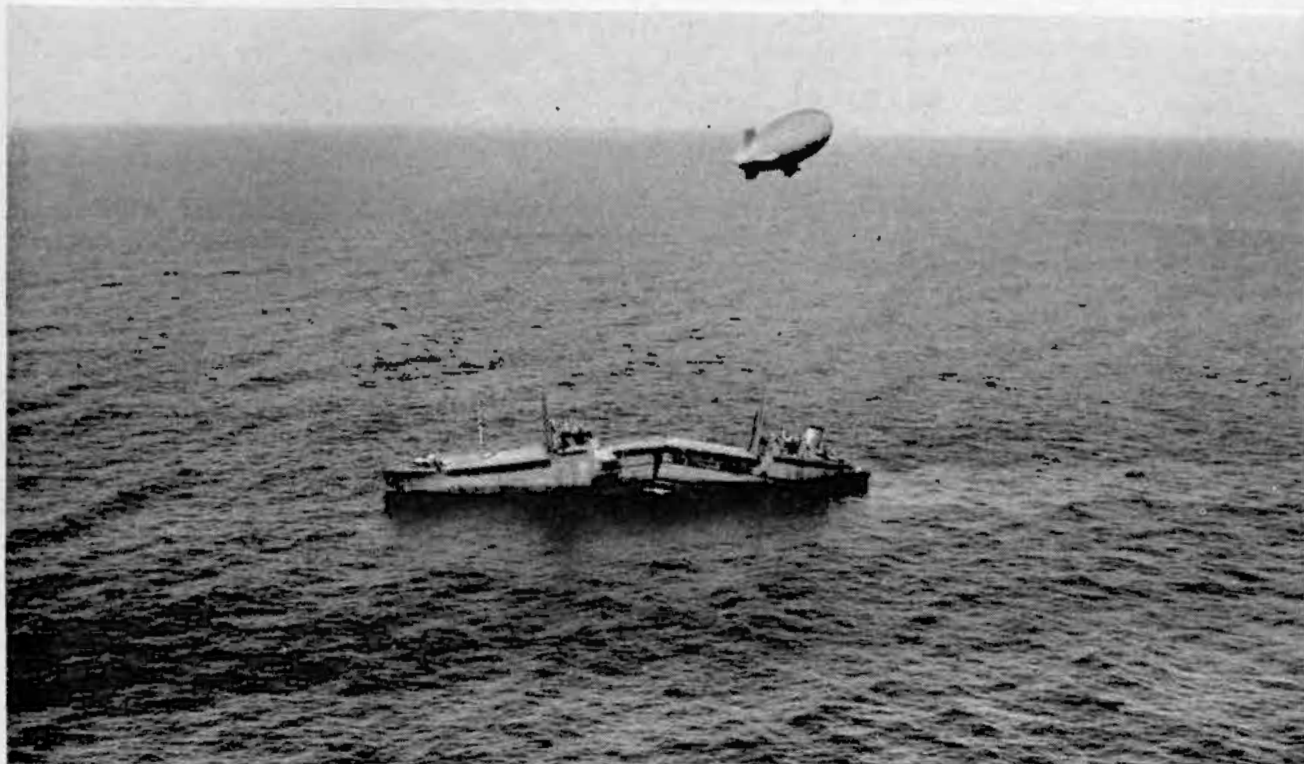
S.S. Ezzo Manhattan

APPARENT STARTING POINT <b>The fracture started in a butt weld between plates A-9 and A-10 at the crown of the deck.</b>
GENERAL HISTORY AND DESCRIPTION OF FAILURE, INCLUDING KNOWN CONTRIBUTORY FACTORS: <b>With a sound described variously as a thump, thud, bang, crash or explosion, the fracture ran across the deck in way of #6 tank, and down both sides, progressing to the bilge port and starboard. The vessel jack-knifed and the bow dug under an oncoming wave. The crew abandoned in the boats and were picked up by the USCG KIMBALL. The bottom fractured later and the two portions drifted apart. Subsequent examination and tests of the steel in the vicinity of the starting point and from each plate around the periphery of the hull near the fracture indicated that it met existing standards. The chemistry was normal for the class of steel. Impact and notch bend tests showed that much of the steel was sensitive to notches and low temperature. The butt weld in which the crack started contained oxide, slag and porous areas.</b>

CLASSIFICATION OF FAILURE <b>Broke in two</b>

<b>Repaired on drydock at Todd Erie Basin and returned to service.</b>	
SIGNED (Name and Title)	DISTRICT

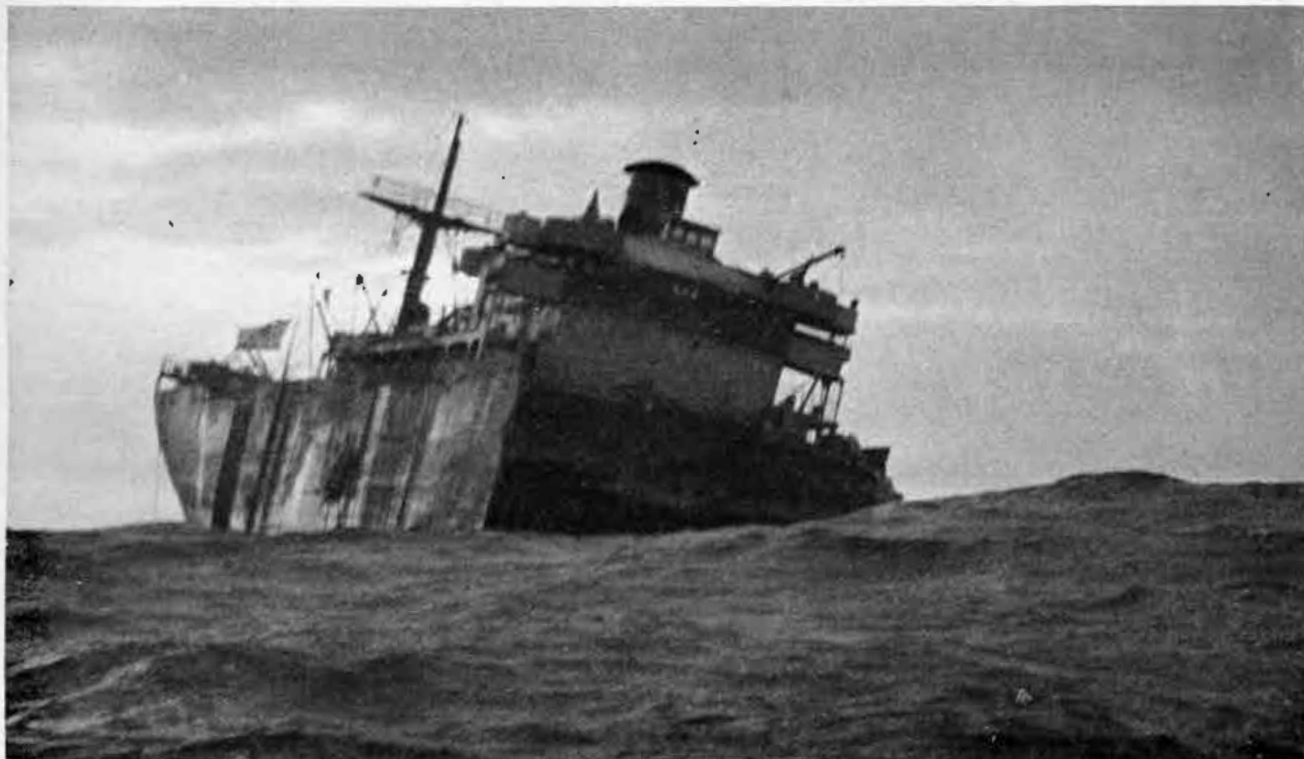
S.S. John P. Gaines

No lives have been lost as the result of structural failures, except in the case of the *John P. Gaines* where ten persons are missing after successfully embarking in a lifeboat.

APPARENT STARTING POINT <b>Near Fwd. corners #3 hatch between frs. #74 and #75.</b>
GENERAL HISTORY AND DESCRIPTION OF FAILURE, INCLUDING KNOWN CONTRIBUTORY FACTORS: <b>At about 2200 on 23 November, 1943, loud noises were heard but the source could not be located in the dark. At about 0241 on 24 Nov., 1943, an exceptional sea known locally as a "freak" or "sneaker" struck the port bow, curled around the stem, and boarded near the forward gun. The fracture which had apparently commenced during the night immediately propagated. It appears that the vessel broke partially as it passed either over or between swells and the following swell completely broke off the forward end. All crew and passengers were on the after end. Survivors were picked up by U. S. Army Transports except for 10 men, including six soldiers in one lifeboat, which was lost.</b>
CLASSIFICATION OF FAILURE <b>Broke in two</b>

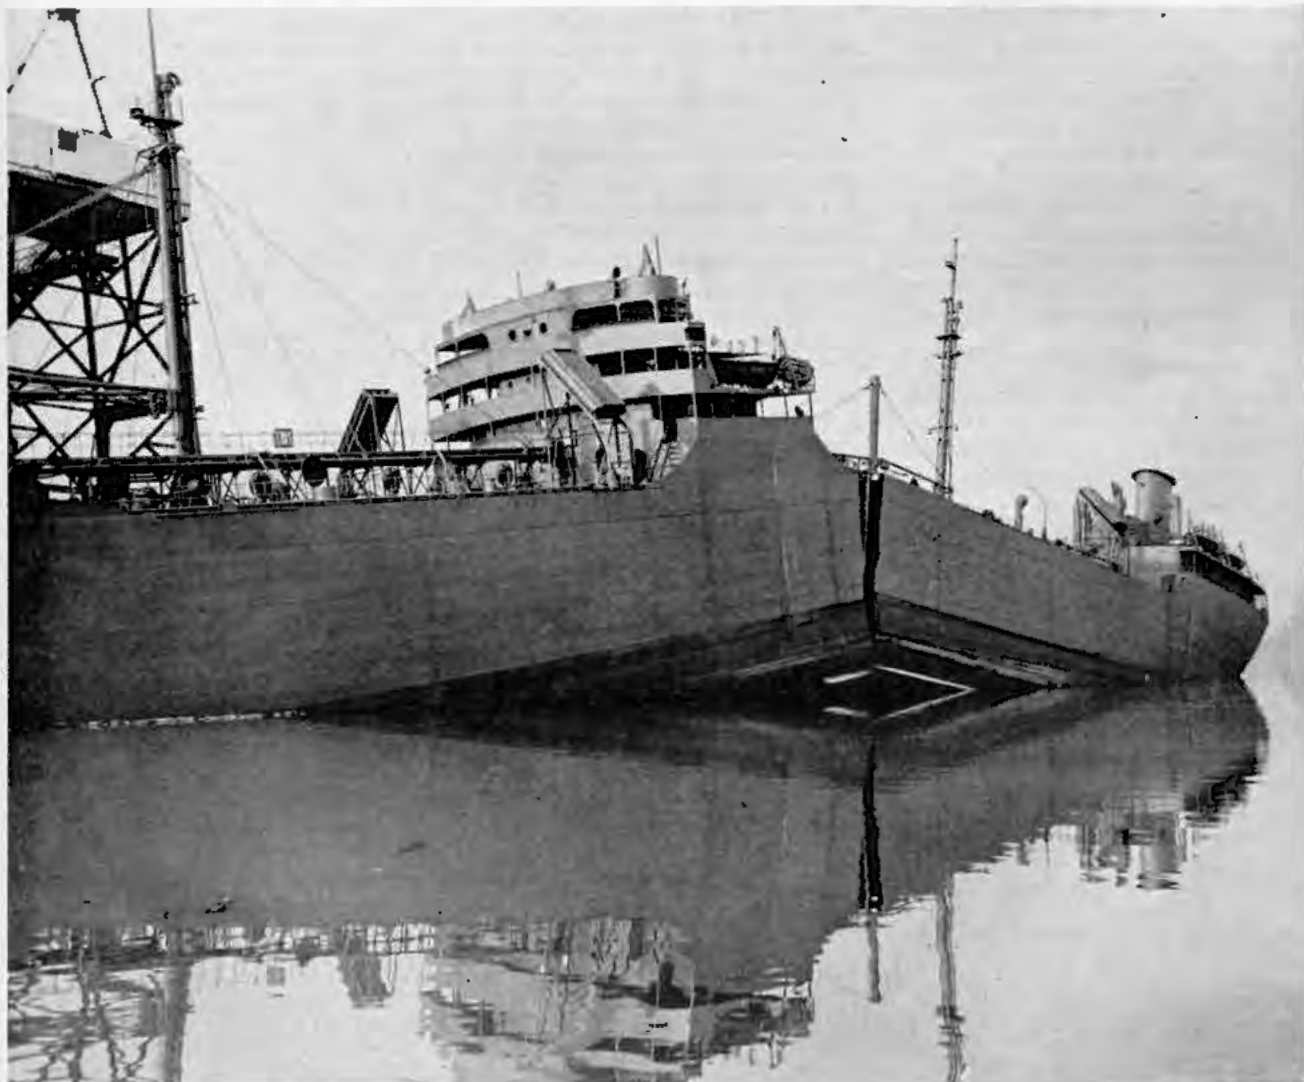
S.S. Schenectady

APPARENT STARTING POINT <b>The fracture started at the juncture of the fashion plate at the aft starboard corner of the bridge superstructure and the sheer strake.</b>
GENERAL HISTORY AND DESCRIPTION OF FAILURE, INCLUDING KNOWN CONTRIBUTORY FACTORS: <b>Without warning and with a report which was heard for at least a mile, the deck and sides of the vessel fractured just aft of the bridge superstructure. The fracture extended almost instantaneously to the turn of the bilge port and starboard. The deck side shell, longitudinal bulkheads and bottom girders fractured. Only the bottom plating held. The vessel jack-knifed and the center portion rose so that no water entered the hull. The bow and stern settled into the silt of the river bottom. Sounding taken around the vessel eliminated the alleged possibility of the vessel having grounded amidships due to a drop in water level. A slight earth tremor was alleged to have occurred at the time of the casualty. The steel of the sheer strake was slightly below specification in yield point and ultimate strength. The deck stringer was low in yield point. Both steels were notch sensitive at low temperature, but there is no existing specification for this characteristic.</b> (continued on reverse side)

CLASSIFICATION OF FAILURE <b>Broke in two</b>

<b>Vessel repaired and put in service.</b>	
SIGNED (Name and Title)	DISTRICT
